## How Trees Cause Outages

by John Goodfellow and Paul Appelt

### ABSTRACT

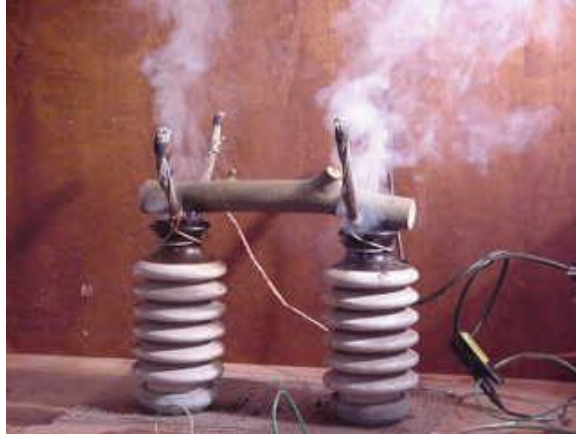
Both experimental procedures were conducted in a controlled high voltage laboratory setting. Individual test specimens were placed between two conductor segments positioned a fixed distance apart. This configuration permitted the branch specimens to be consistently positioned for each testing sequence. This design allowed a predetermined test voltage level to be impressed uniformly across a fixed distance, achieving the desired voltage stress gradient.

**Figure 1. Specimen under high voltage testing.**

The voltage gradient impressed on each specimen was controlled and varied for different sample lots by varying the voltage input. A variable output AC high potential test transformer provided a means of voltage control. A 60:1 power transformer with a maximum rated output of 15 kilovolts was used as a high voltage source. An instantaneous current-sensing trip coil of a protective relay protected the test circuit. The relay was set to interrupt at fault current level of 275 mA. Test set instrumentation provided for a continuous record of time and current, as well as real-time observations of current, time and voltage. When the voltage stress gradient was applied to each test specimen, a timer was automatically actuated. Each test was concluded when the current level flowing through the test specimen exceeded the test set output, tripping the protective circuit breaker. In each case, the time to fault (defined as current flow sufficient to cause the instantaneous current sensing trip coil of a protective relay to operate) was recorded. Tests were also declared complete for those specimens that failed to flash over when the fault current levels being measured dropped to a steady level well below that observed on initial energization. A third variant occurred when the specimen failed by either burning through or falling clear.

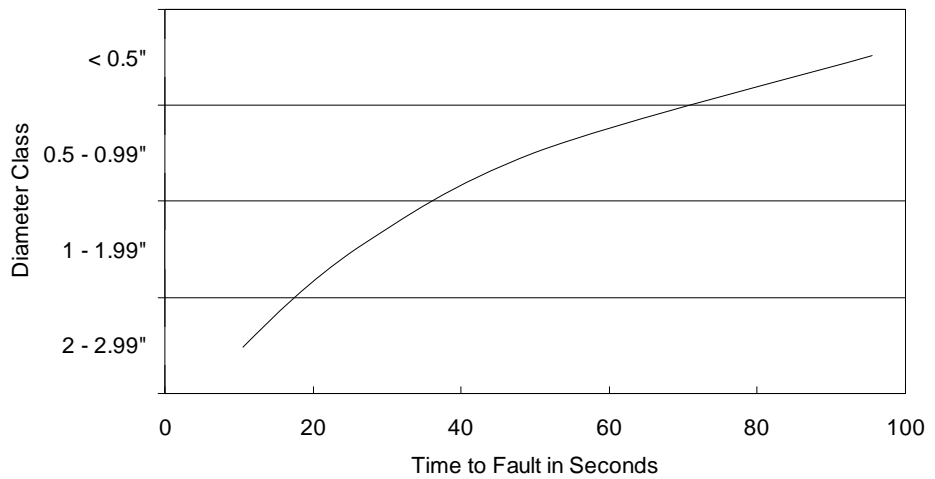
- ◆ Electrical Conductivity Varies by Branch Diameter. Time-to-fault decreases as diameter increases at a given voltage stress gradient as illustrated in Figure 3.

**Figure 3. An example of mean variability in measured conductivity observed over the range of diameter classes for a single species (red alder) at 3kV per foot voltage stress gradient.**

Branch diameter was shown to play a major role in conductivity, with the largest branches being much more conductive than small shoots. This factor should be considered in developing risk assessment criteria. In terms of tree morphology, larger branch diameters occur closer to the main stem. By definition then, conductor contact with larger diameter branches will more often occur with trees in very close proximity to overhead lines. These high-risk contacts will also develop over a long period of time. Branches of only a few growing seasons in age represent relatively lower risk. The implication is that periodic assessment should allow identification of higher risk tree-conductor contacts before they are manifest as an interruption.

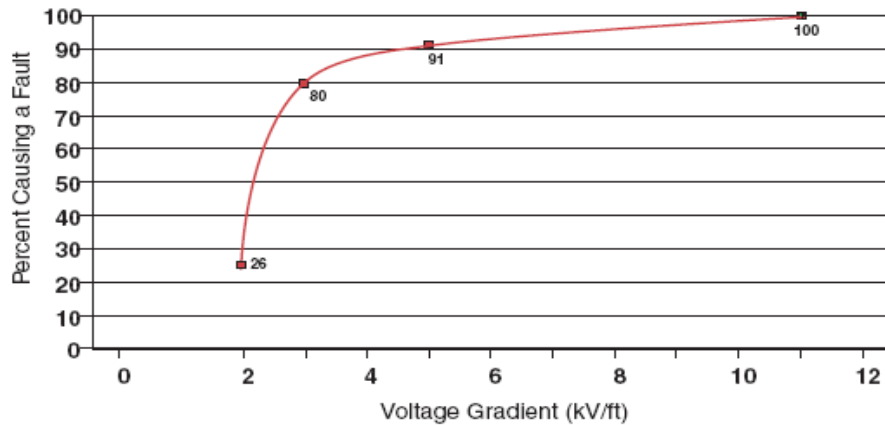
- ◆ Voltage gradient is the most important factor in determining the risk of tree-initiated, low impedance, high current faults. Figure 4 clearly demonstrates the importance of voltage gradient as a factor in determining the risk of a tree contact providing a low impedance pathway and resultant high current fault.

Figure 4. The percent of samples that resulted in a fault increased with voltage gradient
