## How Trees Cause Outages

### *Understanding Tree Caused Outages: The Research*

*By Kenneth E Finch, Environmental Consultants, Inc.*

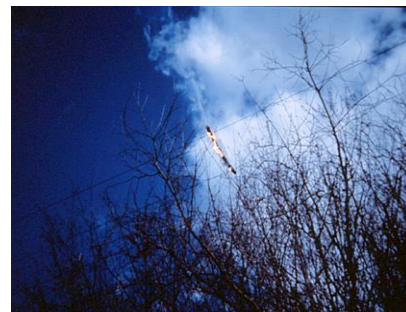
**Figure 1. Photo compliments of Chad Devine, BG&E**

- Incidental tree contact does not pose a significant outage risk.
- An electric fault did not occur until a carbon path was formed between conductors (phase-to-phase or phase-to-neutral).
- A fault does not occur instantaneously when two conductors are bridged. Time seems to be necessary, and water and steam are expelled from the branch during the carbonization process.
- The impedance (resistance) of the tree must change before it will conduct enough current to fault.
- The distance between conductors seems to affect the time required to create the carbon path.

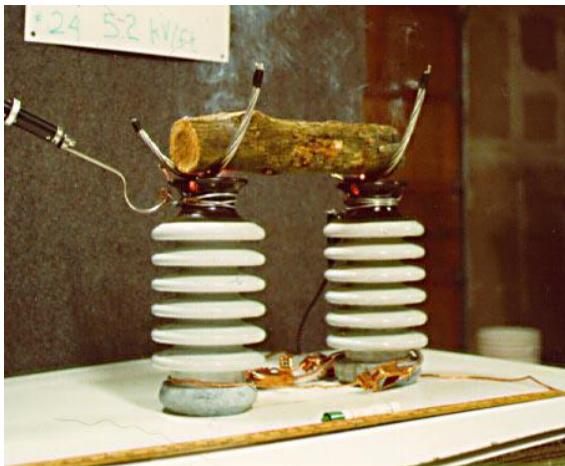
### Figure 2. Laboratory test setup

A high voltage test bench was assembled, with insulators positioned a fixed distance apart. Specimens were placed within saddles formed of aluminum wire, allowing consistent positioning for each test sequence. A variable output AC high potential transformer allowed for uniform testing at predetermined voltage levels.<sup>ii</sup>

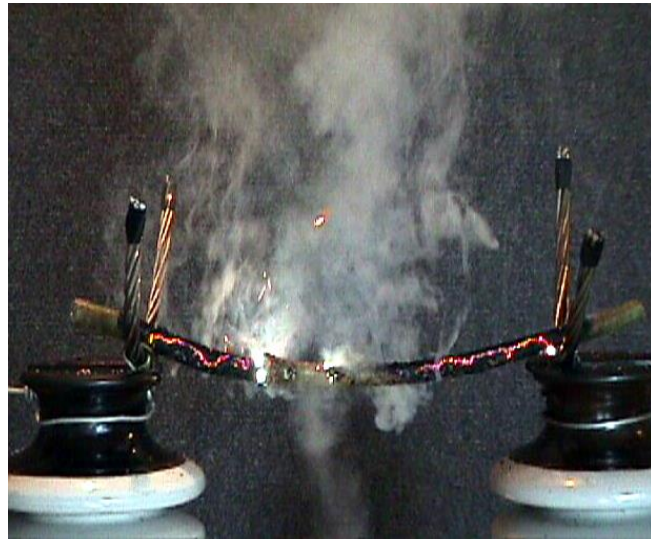
**Figure 3. Formation of the carbon pathway prior to flash over**

for years insulated line clearance tools were made of wood. The question was when do they become conductive? Quite simply the carbon path becomes the more conductive route for electricity across the wood.

In their discussion of the “Conceptual Model of the Electrical Mode of Failure” in the 1998 report ECI states; “The electrical stress at the point(s) of contact are due to unequal potential across the conductor surface, branch surface (outer bark), inner bark (cambium), and xylem (wood). The electrical stress causes arcing; a high energy point discharge. Heat energy generated from the arc is sufficient to cause breakdown of organic compounds (cellulose and lignin) into elemental carbon and charcoal. The carbon generated is relatively conductive as compared to branch tissue.”<sup>iii</sup>

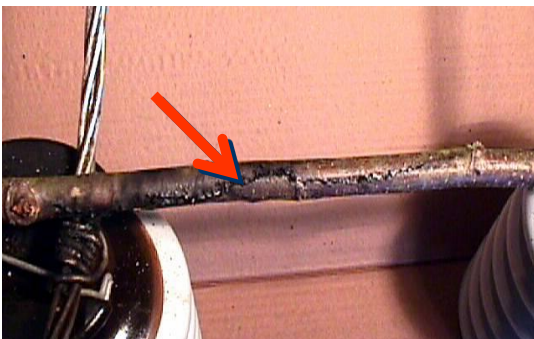
**Figure 4. A completed carbon path, fault occurred**

The pathway is largely evident as a “blackened area of charcoal” across the branch surface, between the two points of contact. When the pathway was not evident on the surface, branch dissection often revealed internal tracking. Once the pathway was complete, a fault was instantaneous each time the branch was re-energized.<sup>iv</sup>

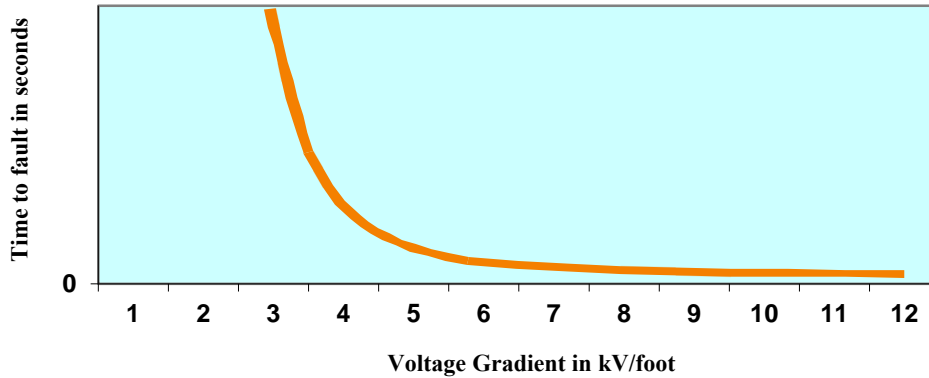
The studies also confirmed that voltage gradient is the variable with the greatest effect on outage risk. Figure 5 shows the time in seconds for a carbon path to form and the fault to develop, decreases rapidly as voltage gradient increases. While BG&E suggested the fault is not instantaneous when two conductors are bridged, the time and current measurements showed it can be nearly instantaneous at higher gradients. At the same time, the steepness of the curve at lower voltage gradients clearly suggests a threshold exists below which a carbon path will not form.<sup>v</sup>

Figure 5. Influence of Voltage Gradient on Time to Fault

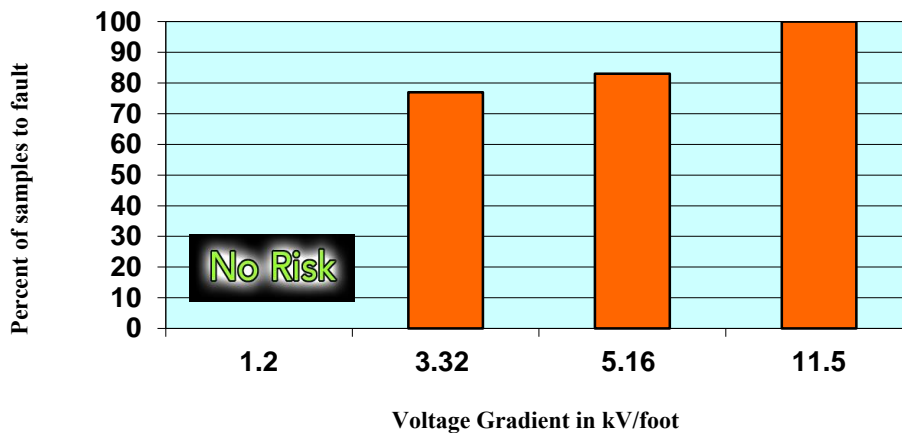
Figure 6 confirms the threshold theory. It examines the results from the first (1998) study, in which more than 300 specimens were tested at four pre-determined voltage gradients. There were no outages at the 1.2 kV/foot gradient, and 100 percent failure at 11.5 kV/foot. Variability in outage risk exists at the 3.32 and 5.16 kV/foot gradients, indicating there may be differences among species and related to other wood characteristics.<sup>vi</sup>

Figure 6. Influence of Voltage Gradient on Likelihood to Fault

While the 1998 study tested the samples at specific voltages and no outages occurred below 1.2 kV/ft., the 1999 study tested specimens at gradually declining voltage gradients until a no fault threshold was determined for each species. Significant variability was found between species.<sup>vii</sup> The studies also looked beyond voltage gradient to determine if differences existed between species, as well as several physiological factors such as branch diameter, branch origin, dead wood vs. live wood, and internal and surface moisture condition.
